APPENDIX C

Case Studies

C-2 Guidebook for Airport Terminal Restroom Planning and Design

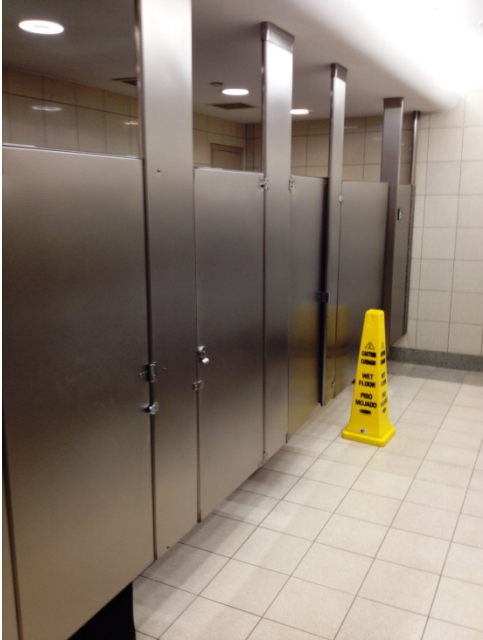
Overhead-braced Stainless Steel Stalls

- The stainless steel textured partitions are good at hiding fingerprints and preventing graffiti.
- Overhead-braced stalls require frequent re-tightening of fasteners due to racking when doors swing.

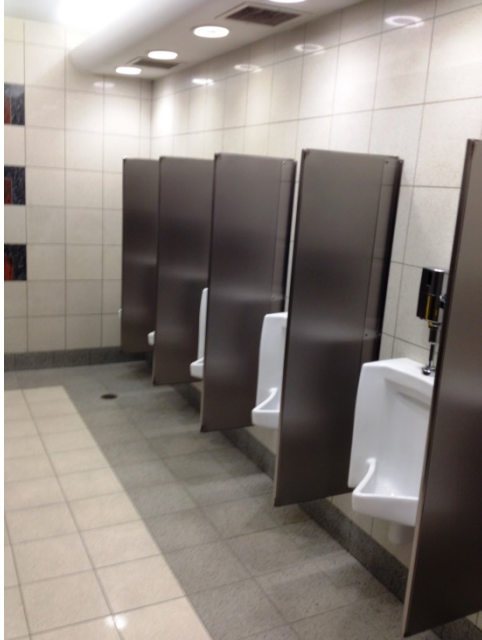
Urinals with Tall Screens for Privacy

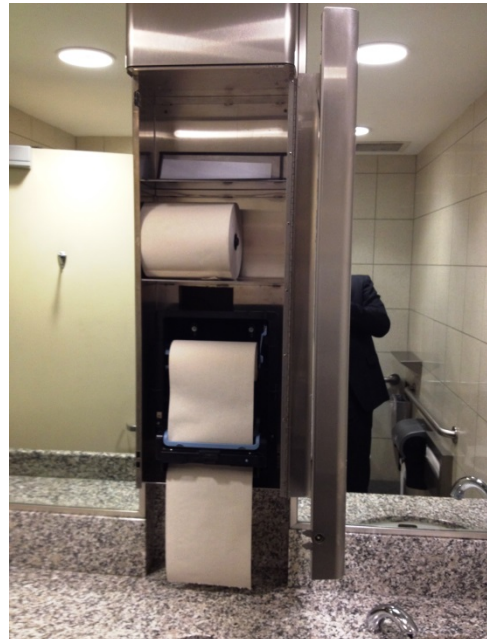
Guts of Custom Paper Towel Dispenser

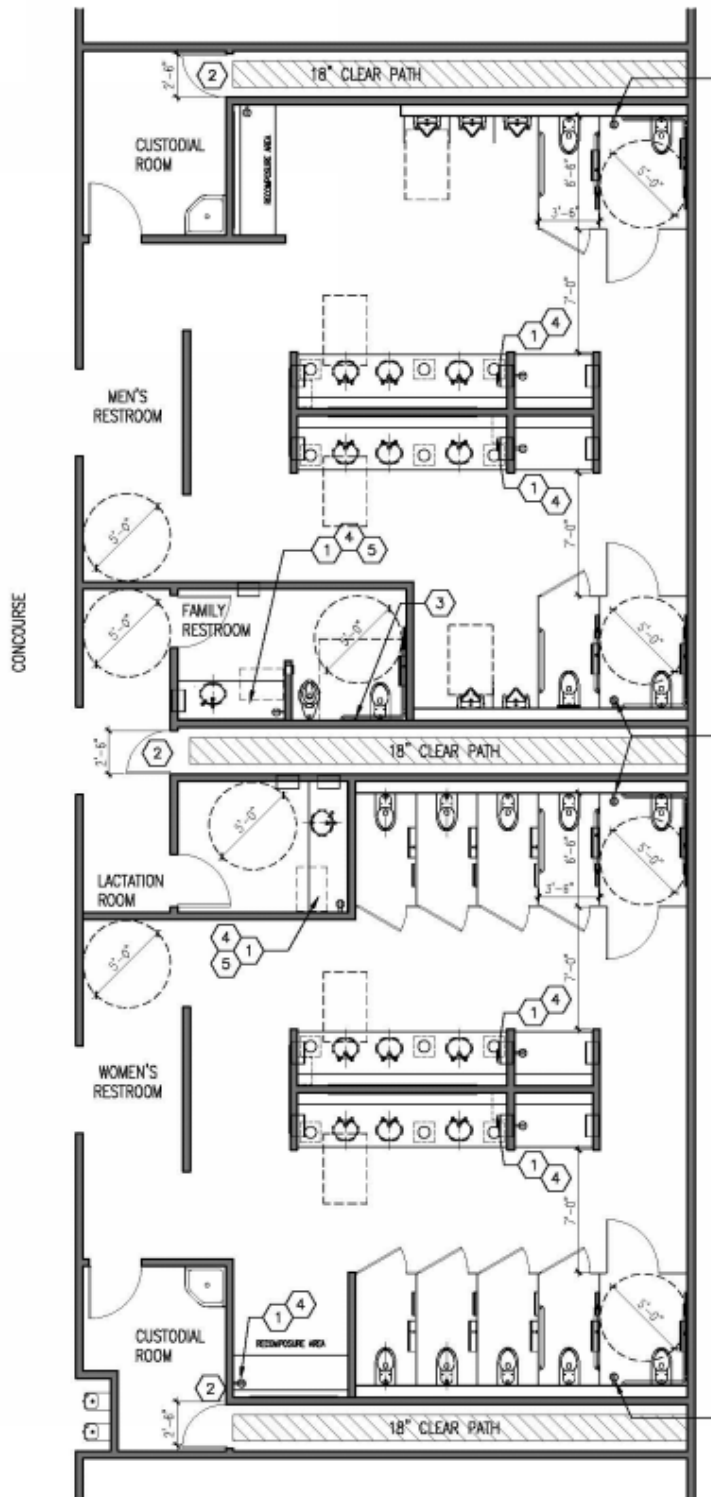
Prototype Floor Plan from LAWA "Public Restrooms Design Intent"

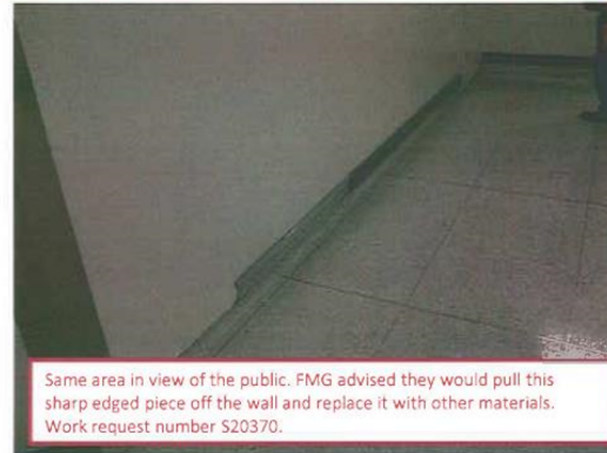
Same area in view of the public. FMG advised they would pull this sharp edged piece off the wall and replace it with other materials. Work request number S20370.

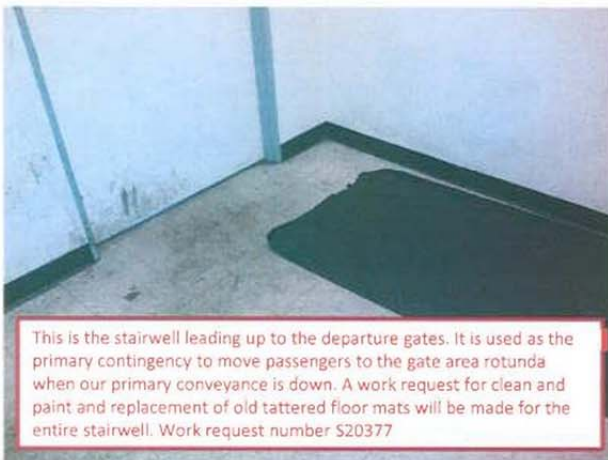
This is the stairwell leading up to the departure gates. It is used as the primary contingency to move passengers to the gate area rotunda when our primary conveyance is down. A work request for clean and paint and replacement of old tattered floor mats will be made for the entire stairwell. Work request number S20377

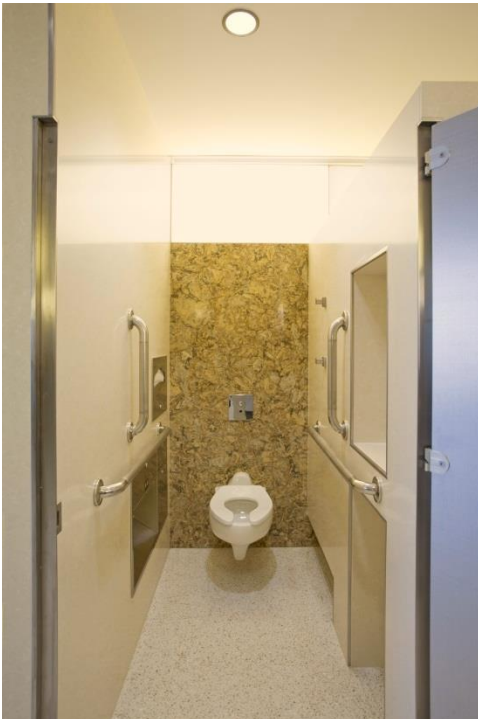
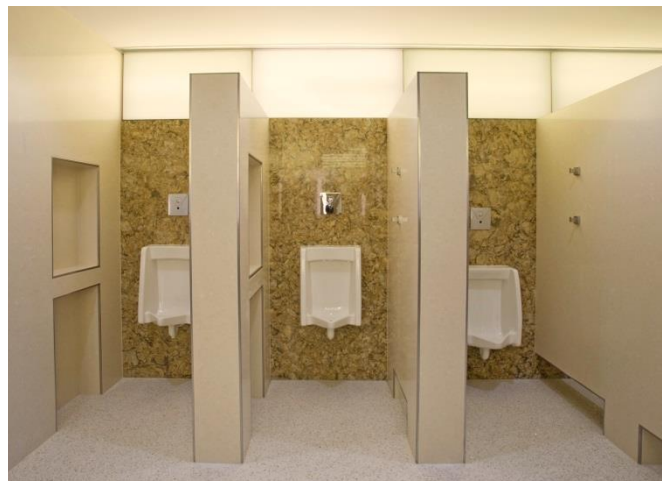
Typical Stall with Thickened Walls Urinals with Thickened Walls Similar to Stalls and Shelf/Alcoves for Belongings

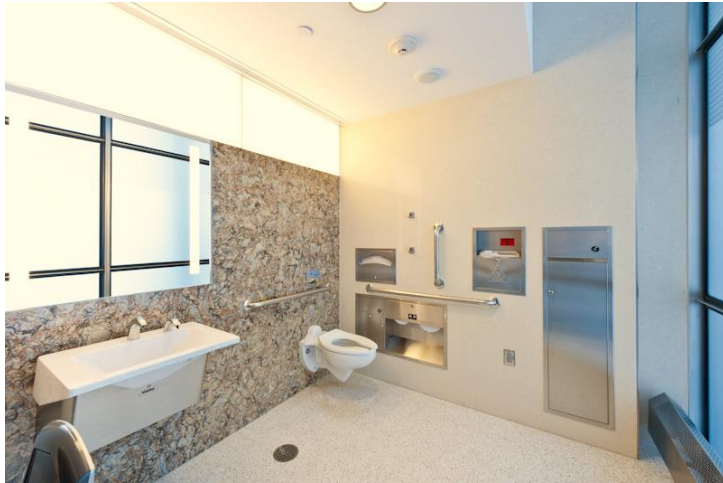
Accessible “Stall” is a private room with Translucent Daylighting on Right

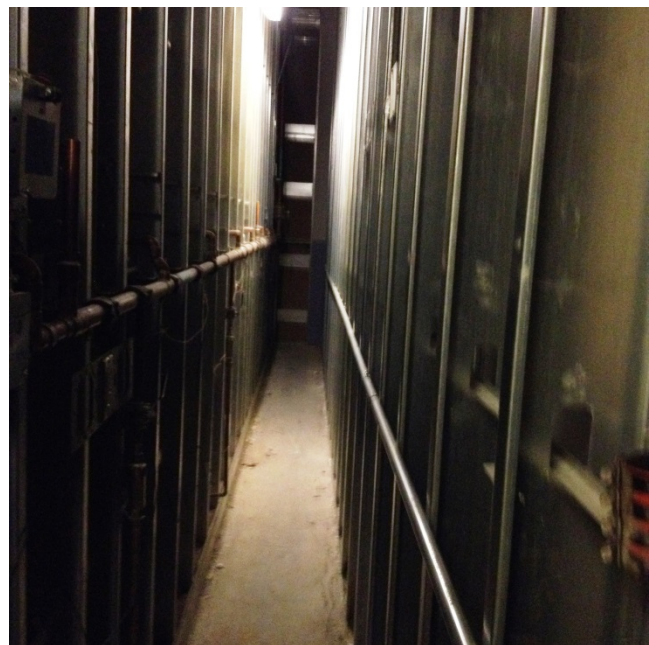
New Pipe Chase with Studs on Concrete Curbs

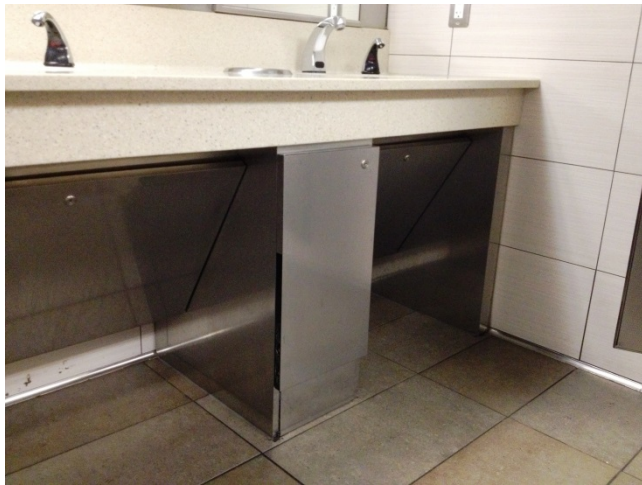
2009 Version of Under-Counter Storage

- In the 2007 restrooms, the sloped trash enclosure below the counters quickly filled because of the way the trash bags had to be squeezed into the space. The 2009 version boxed out an enclosure between the sinks that provided space for a standard trash can.
- Paper towel dispensers require frequent battery replacement. Hard-wired are better and have been implemented.
- Flushometers cause “toilet sneeze” when the occupant moves while sitting or standing and the flush splashes outside the bowl onto the person. Cleaning staff experience the same problem when cleaning.
- Fingerprints on stainless steel partitions require constant cleaning.
- Soap dispenser shoots out soap when people walk by. No way to adjust sensitivity.
- Considering an automatic seat-cover dispenser to help perception of cleanliness.
- Water bottle filling stations are being considered at drinking fountains.

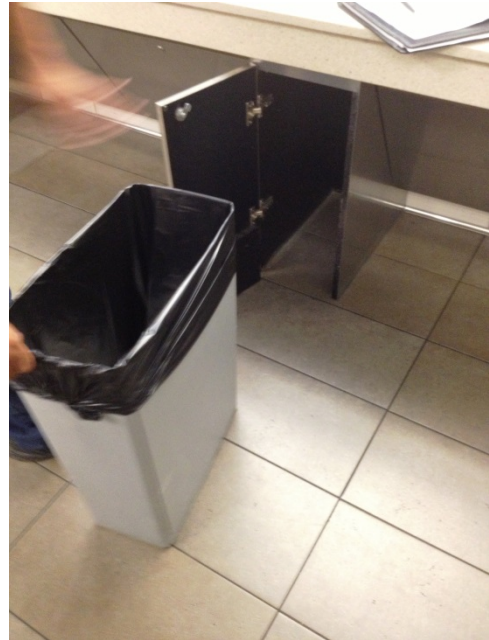
Standard Trash Can Slide Out Easily and Does Not Clog

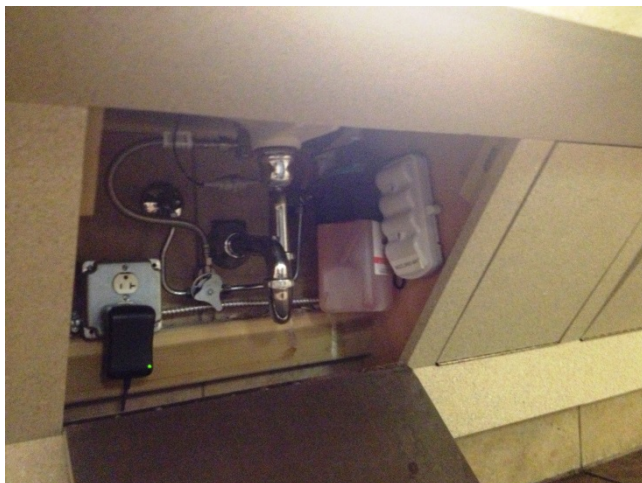
Access to Refill Soap, Traps, and Electrical Below Sink

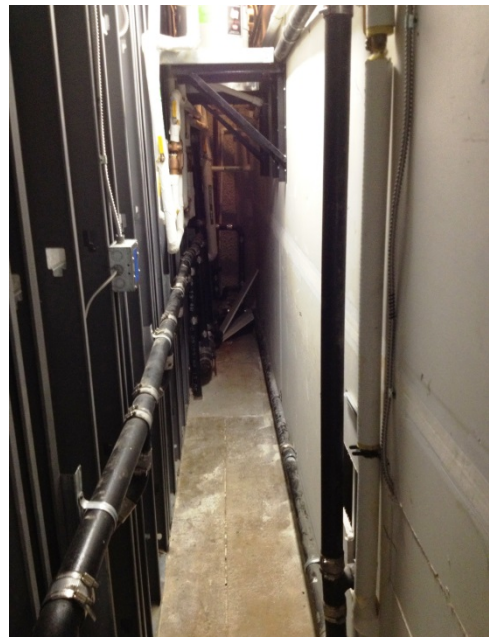
Typical Pipe Chase

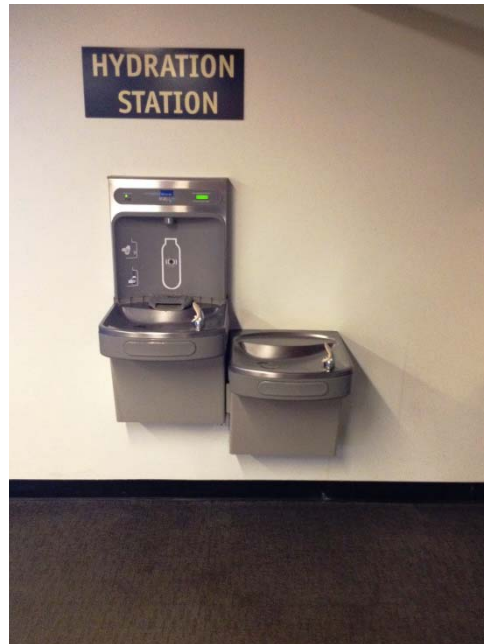
Hi-Lo Drinking Fountain with Bottle Filler
